Type-4 CNG CYLINDER

Operating and Maintenance Manual

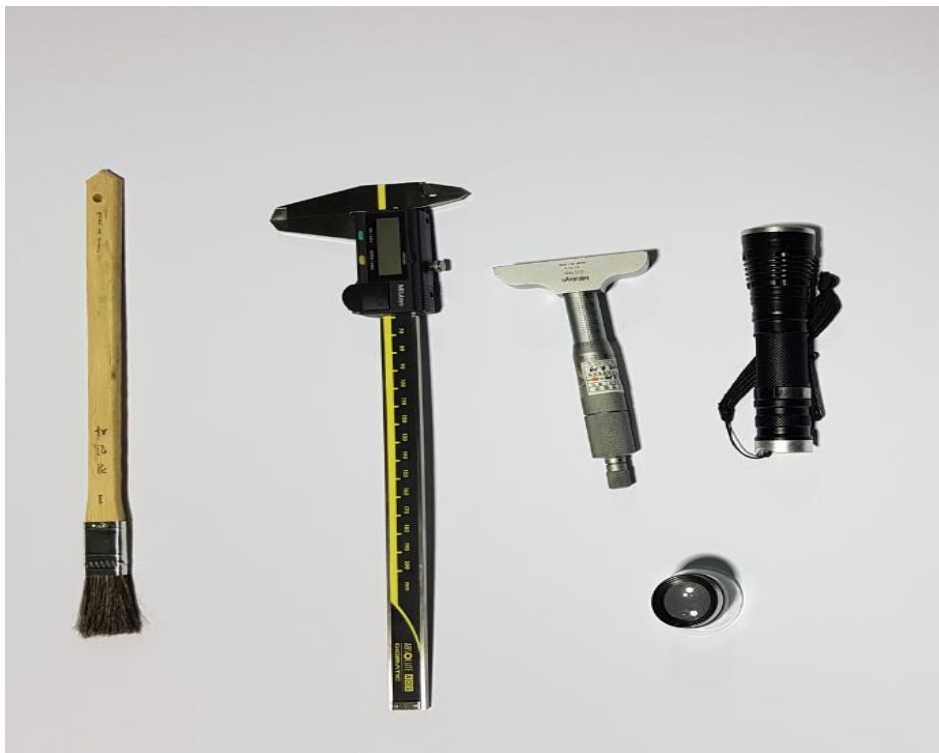
Inspection Tools

- A portable microscope and a flashlight could be useful for inspecting the surface of the cylinder in detail.
 - Use a brush in order to make the clean surface of the cylinder before the inspection.
- Identify how to measure the depth of damage before the inspection.

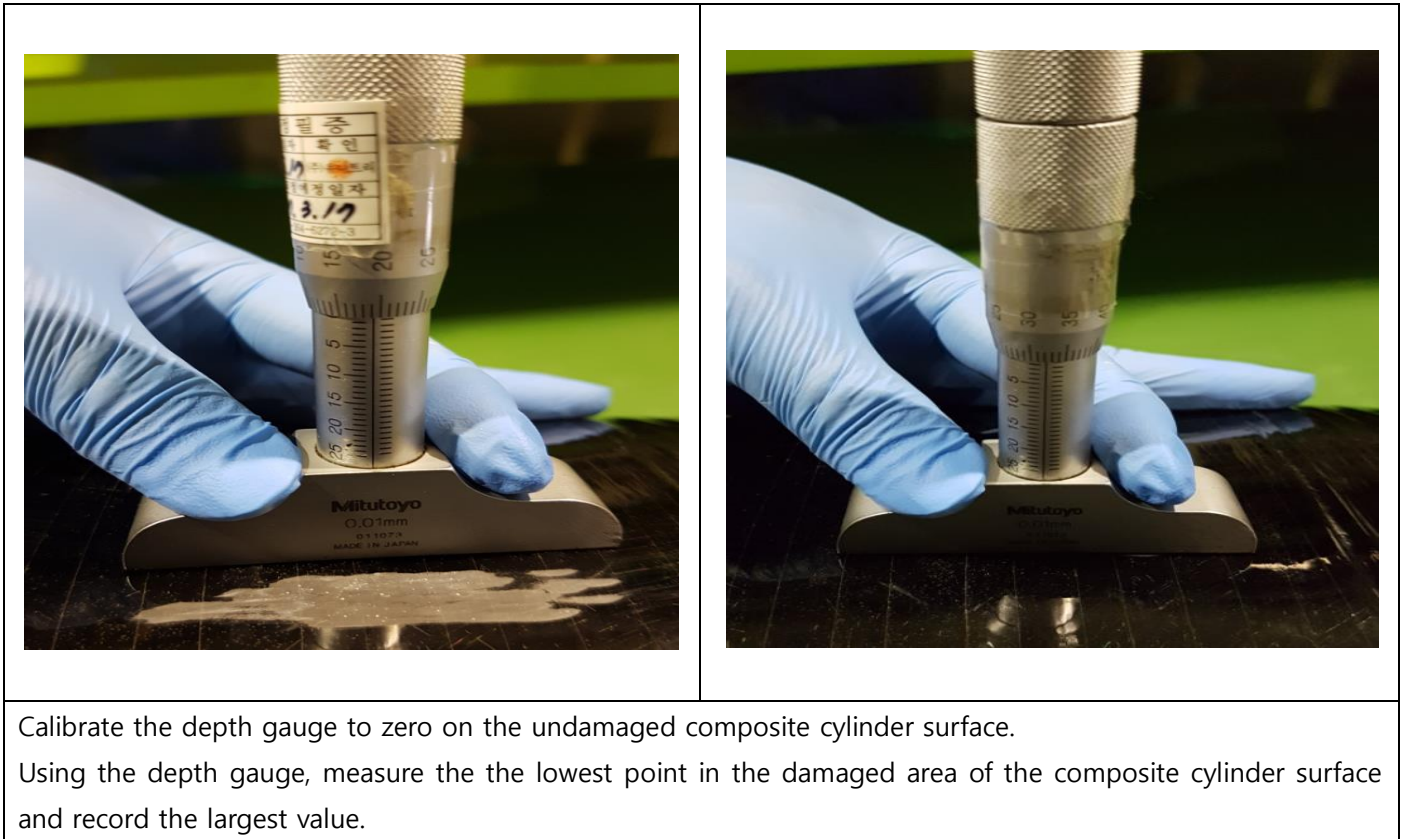
• Measuring the depth of damage

1. Identify the damaged area
2. First calibrate the depth gauge to zero on the undamaged composite cylinder surface.
3. Using the depth gauge, measure the the lowest point in the damaged area of the composite cylinder surface and record the largest value.

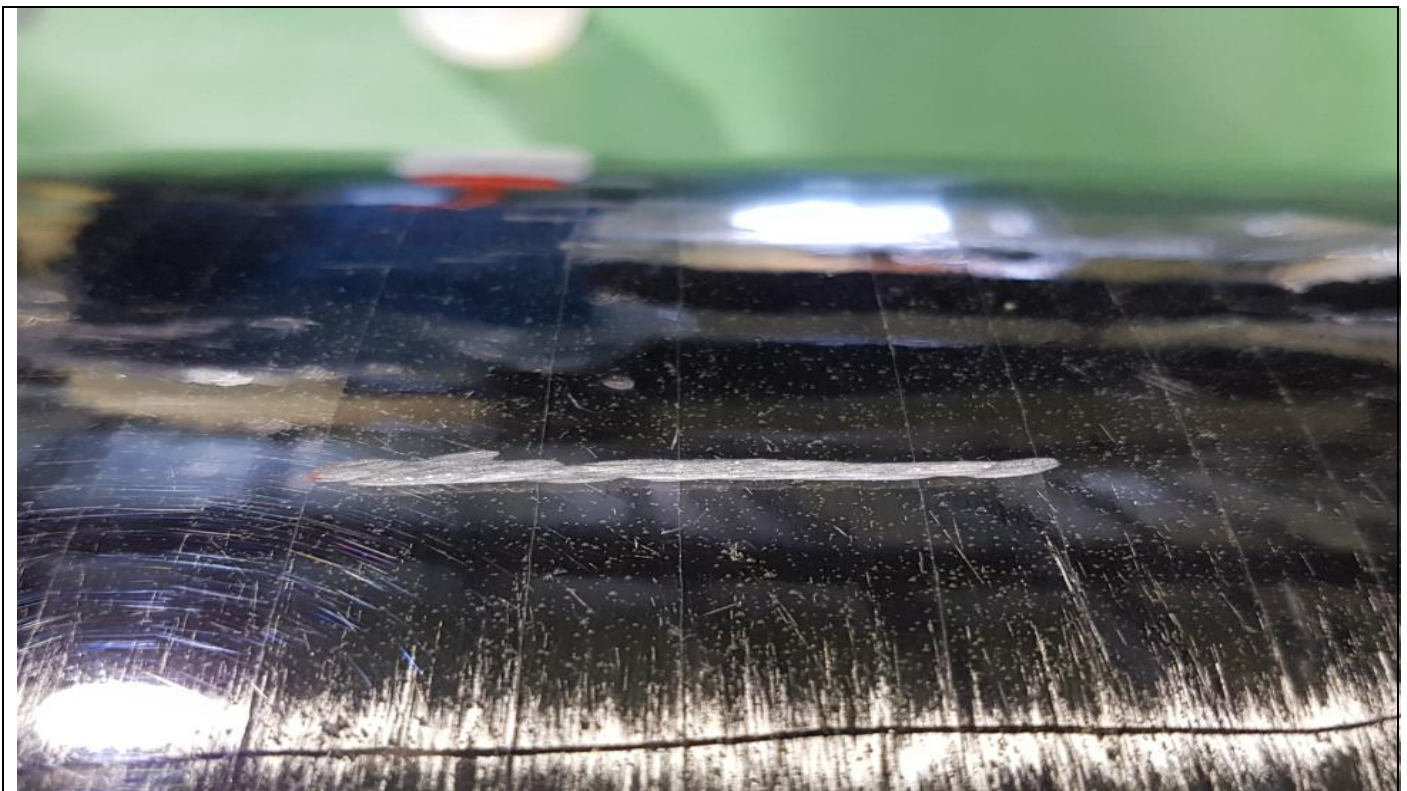
Level 1 cut

The depth of 'Level 1 cut' is between zero and less than or equal to 25 inches (0.25mm)

The depth of 'sample cut' : 0.0039 inches (0.1mm)

Damage Levels		
<u>Cut, scratches, abrasion and gouge</u>		
Damage levels	Depth (inches)	Depth (millimeter)
Level 1	$0 \leq 0.01$	$0 \leq 0.25$
Level 2a	$0.011 \leq 0.035$	$0.26 \leq 0.89$
Level 2b	$0.035 \leq 0.050$	$0.90 \leq 1.27$
Level 3	$0.05 <$	$1.27 <$

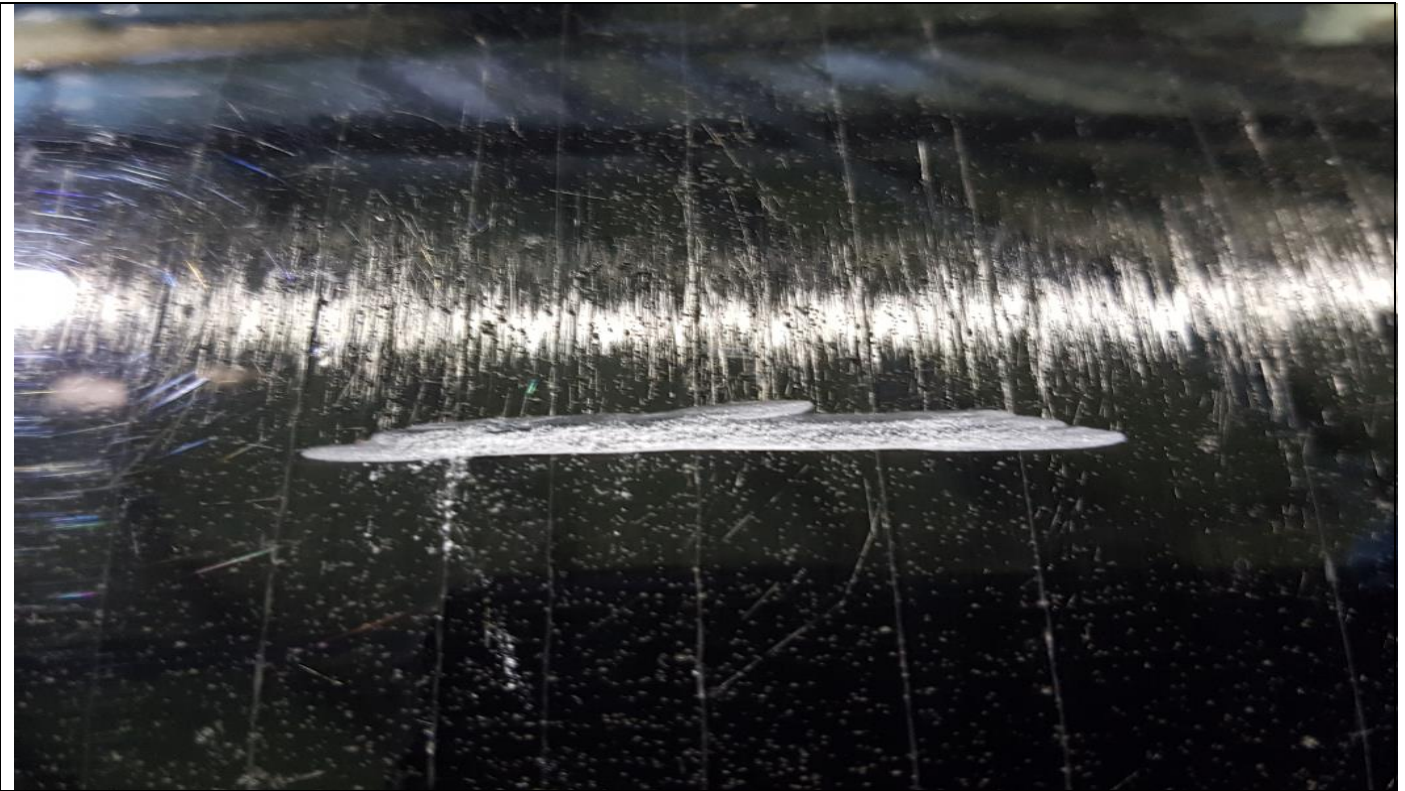
Level 2a cut

The depth of 'Level 2a cut' is between greater than equal to 0.011 inches (0.26mm) and less than or equal to 0.035 inches (0.89mm)

The depth of 'sample cut' : 0.028 inches (0.7mm)

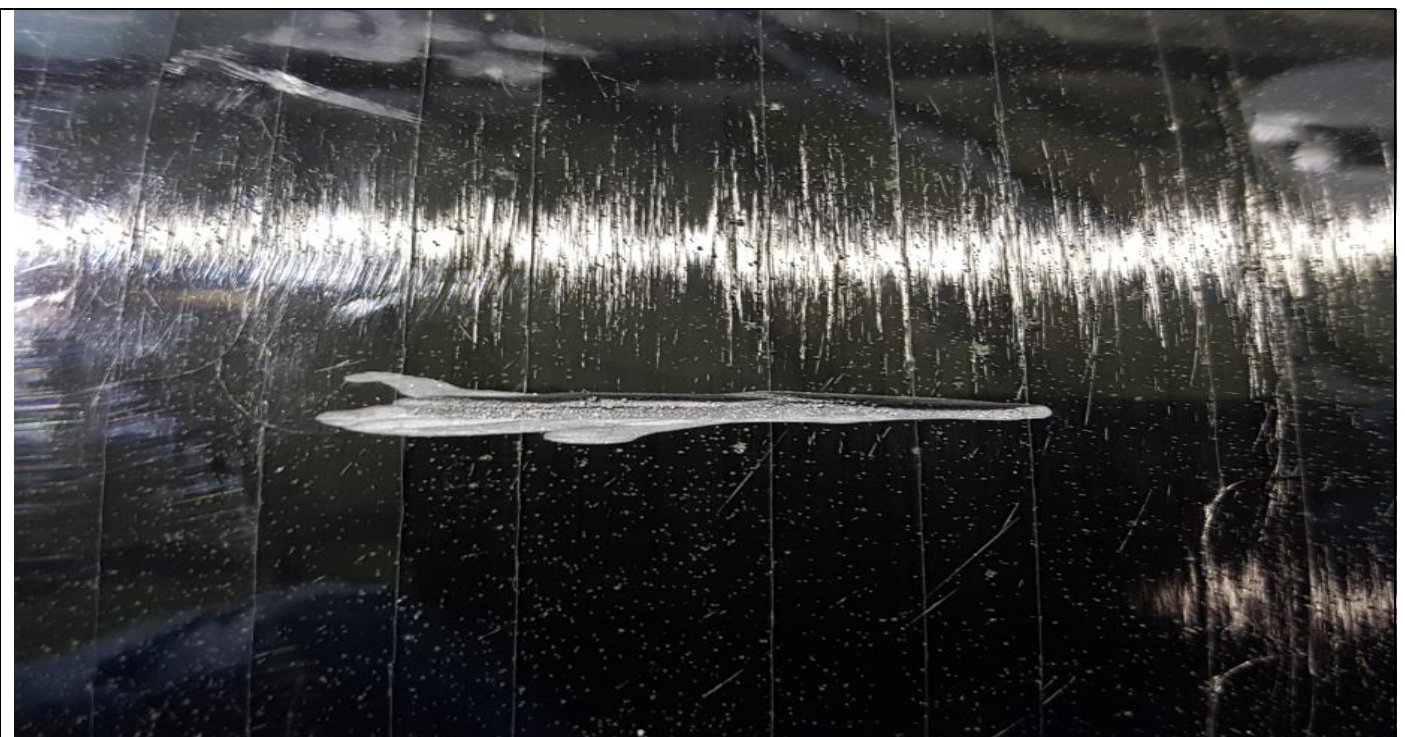
Level 2b cut

The depth of 'Level 2b cut' is between greater than equal to 0.035 inches (0.90mm) and less than or equal to 0.050 inches (1.27mm)

The depth of 'sample cut' : 0.04 inches (1.03mm)

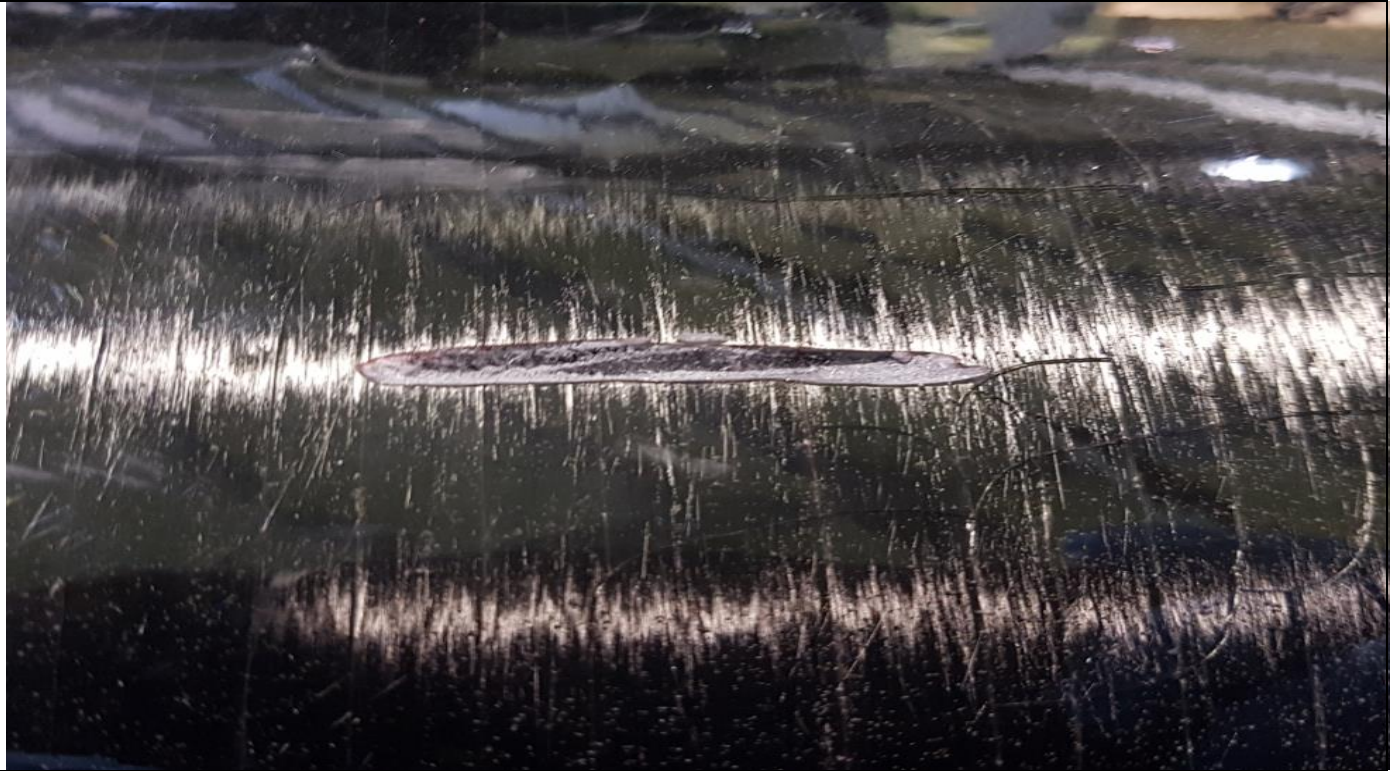
Level 3 cut

The depth of 'Level 3 cut' is greater than 0.050 inches (1.27mm)

The depth of 'sample cut' : 0.093 inches (2.35mm)

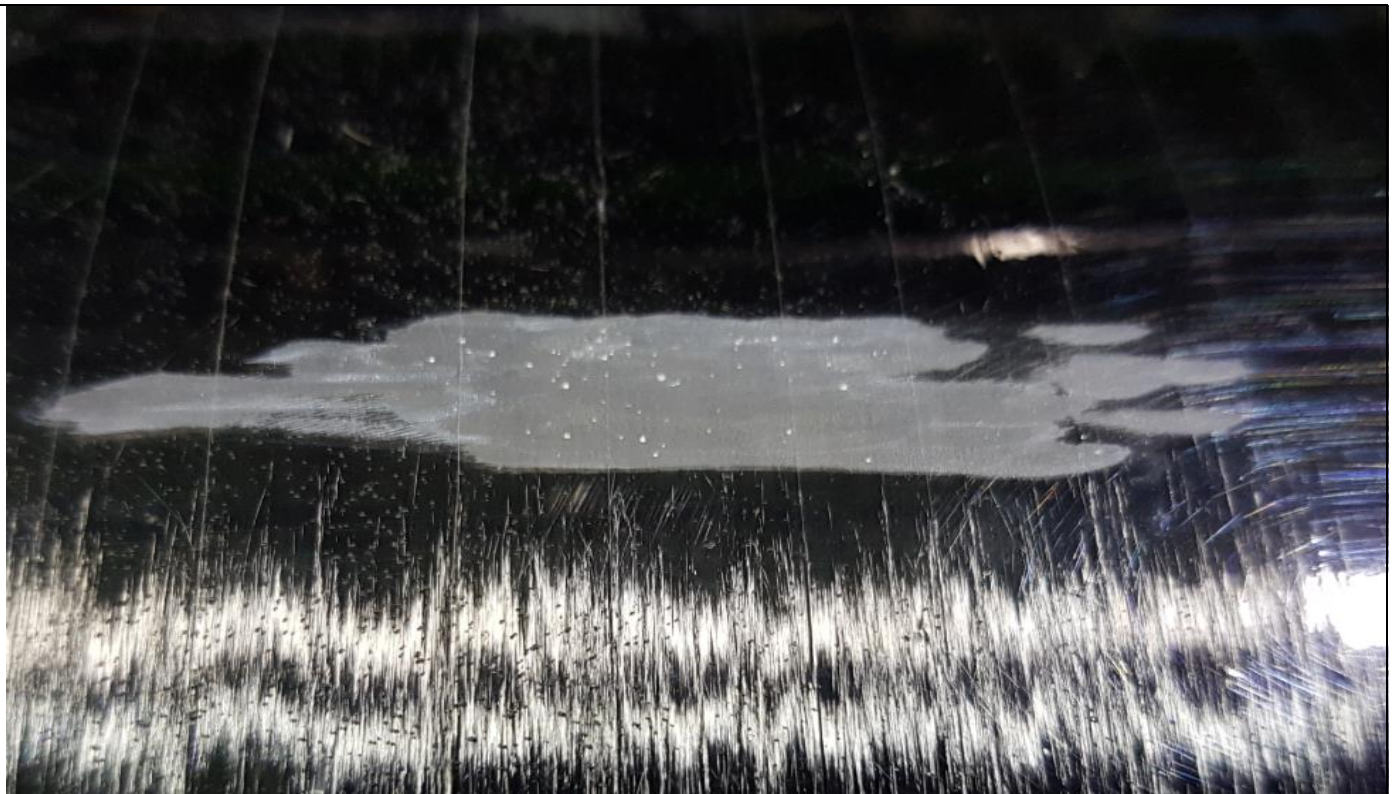
Level 1 abrasion

The depth of 'Level 1 abrasion' is between zero and less than or equal to 25 inches (0.04mm)

The depth of 'sample abrasion' : 0.0016 inches (0.1mm)

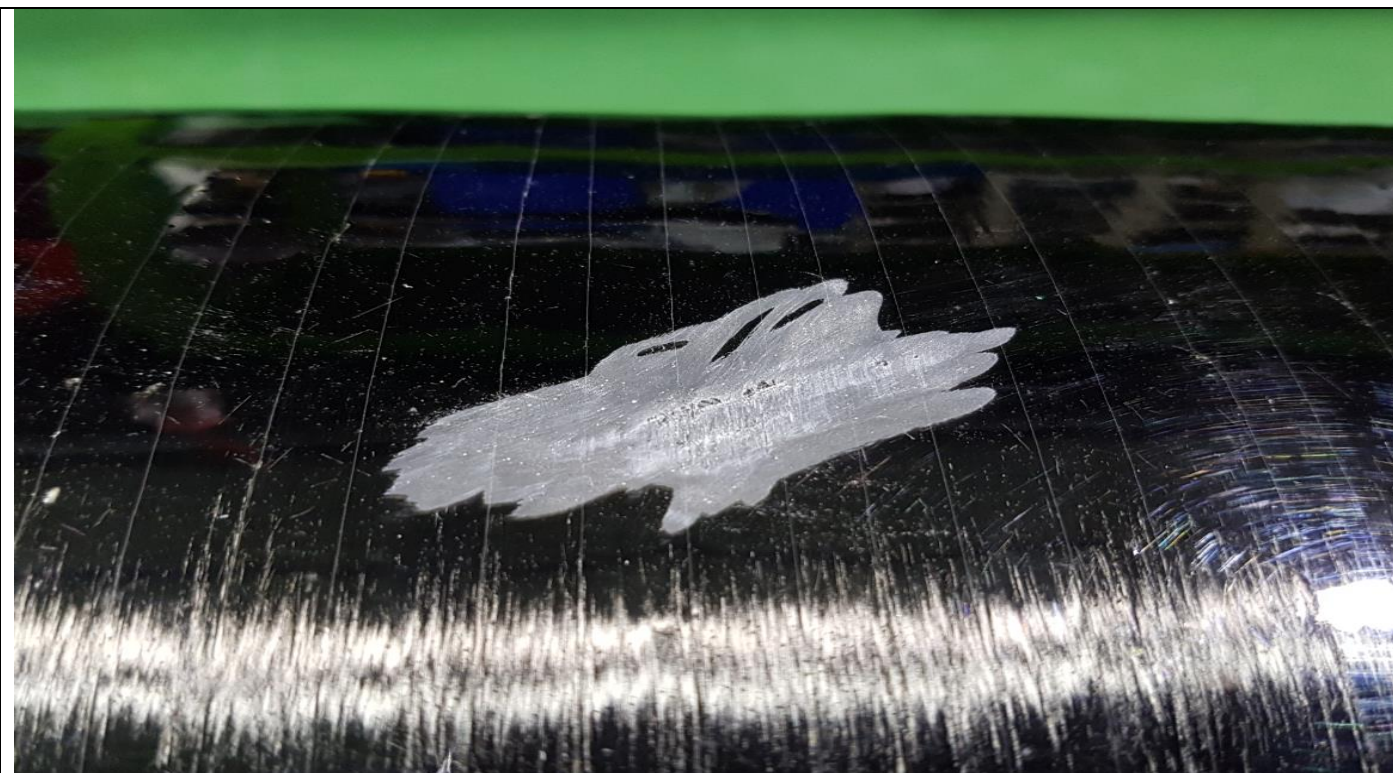
Level 2a abrasion

The depth of 'Level 2a abrasion ' is between greater than equal to 0.011 inches (0.26mm) and less than or equal to 0.035 inches (0.89mm)

The depth of 'sample abrasion ' : 0.034 inches (0.88mm)

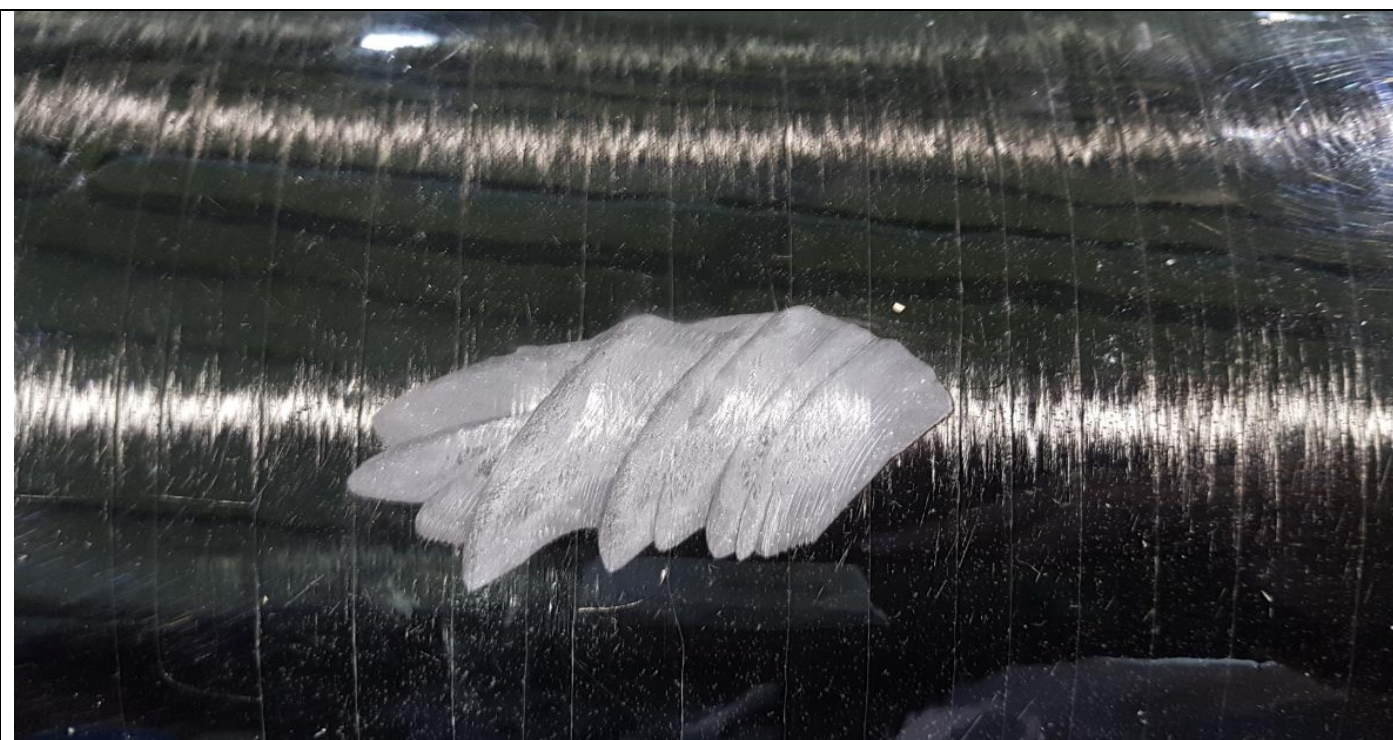
Level 2b abrasion

The depth of 'Level 2b abrasion' is between greater than equal to 0.035 inches (0.90mm) and less than or equal to 0.050 inches (1.27mm)

The depth of 'sample abrasion' : 0.044 inches (1.13mm)

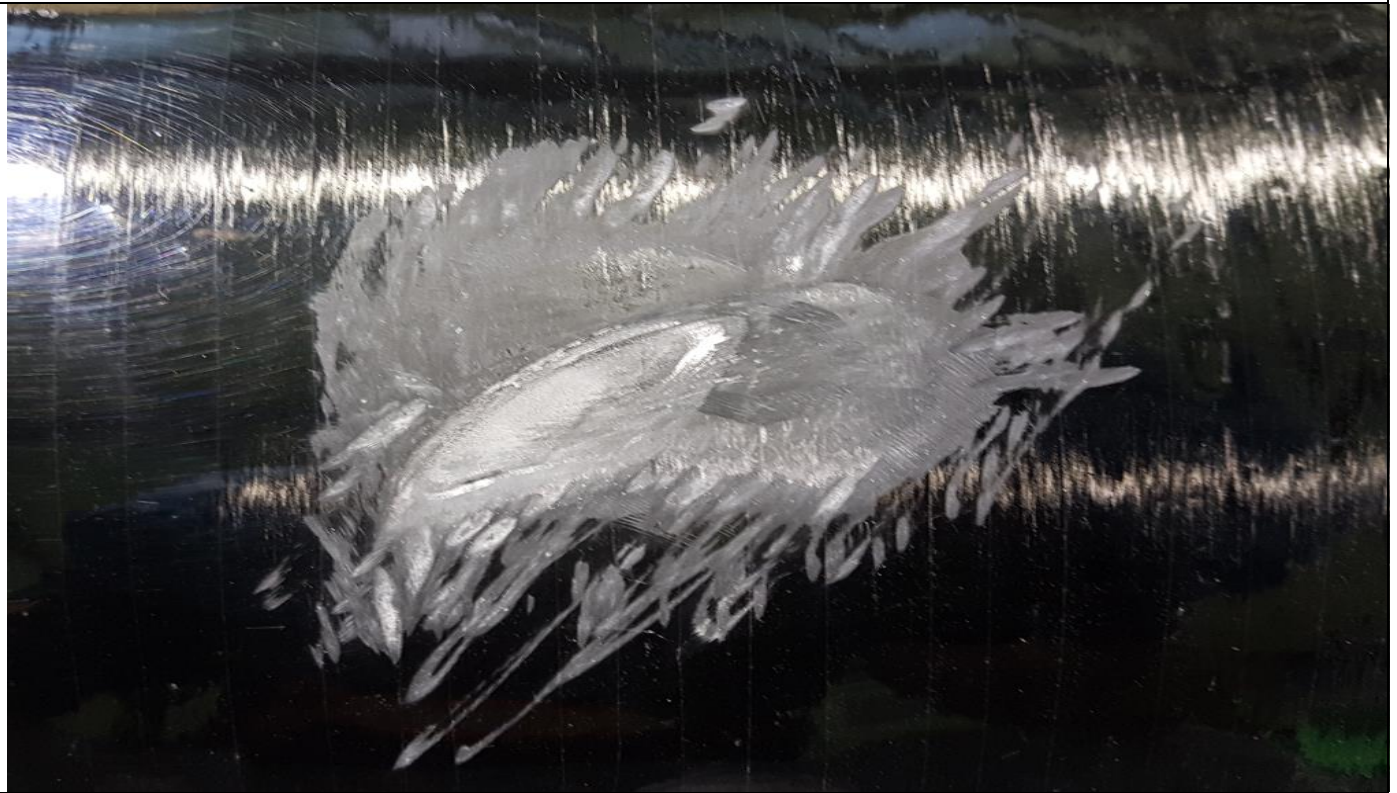
Level 3 abrasion

The depth of 'Level 3 abrasion' is greater than 0.050 inches (1.27mm)

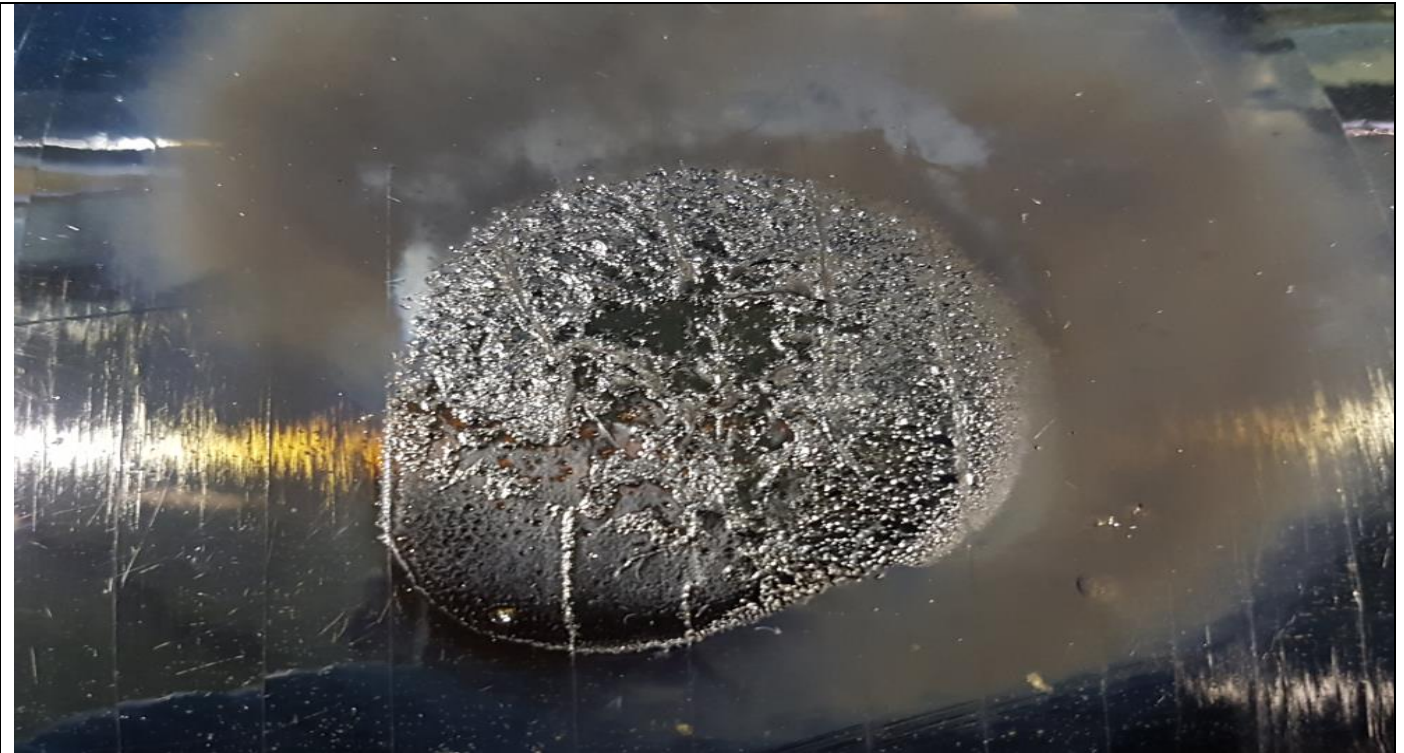
Fire damage inspection

Fire damage can be evident on exposed cylinder surface as you can see the picture.

Evidence of heat damage is darkening, charring, sooting or melting of the composite material. These damages can be easily found on the cylinder surface and result in resin removal and loose fibers.

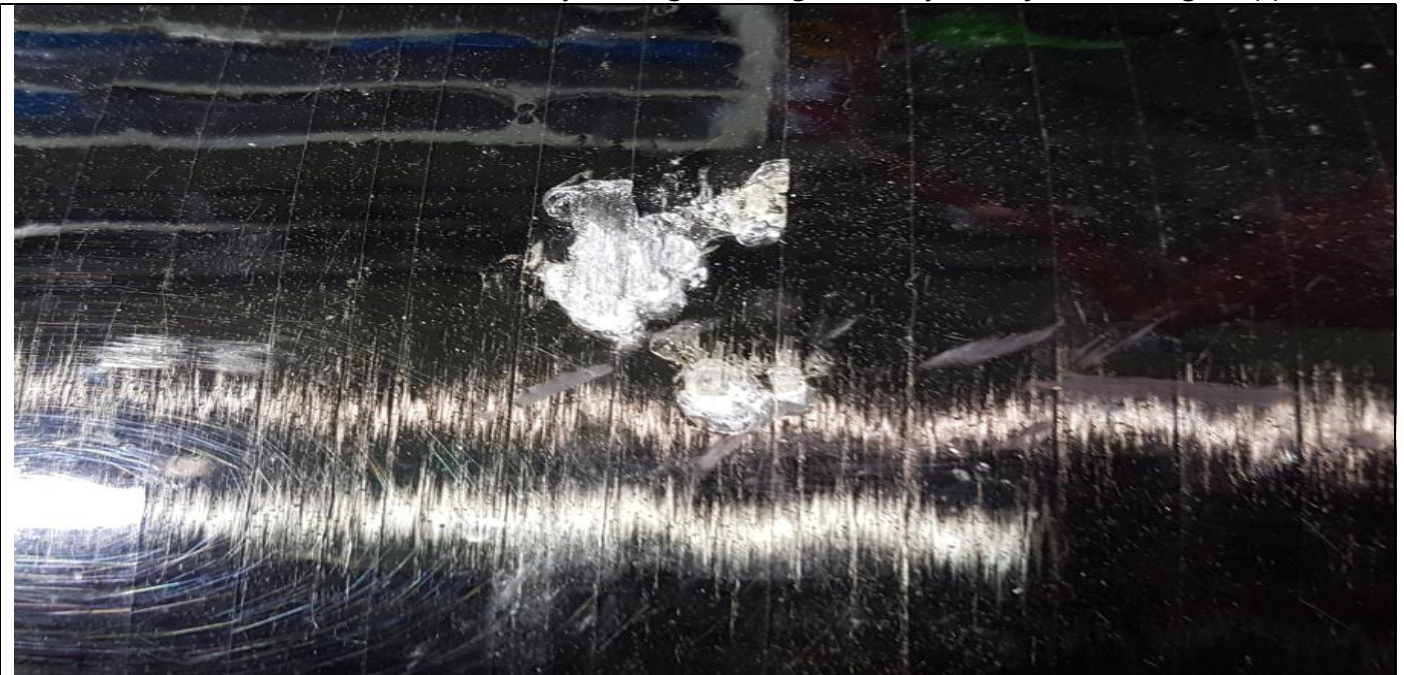
Level 1 impact is light impact damage and usually get frosted.
In this case, the cylinders can usually be returned to service.

-An indication of impact usually appears as a white frosted area in the composite material. Impact indications such as these can be caused by striking or being struck by an object or being dropped.

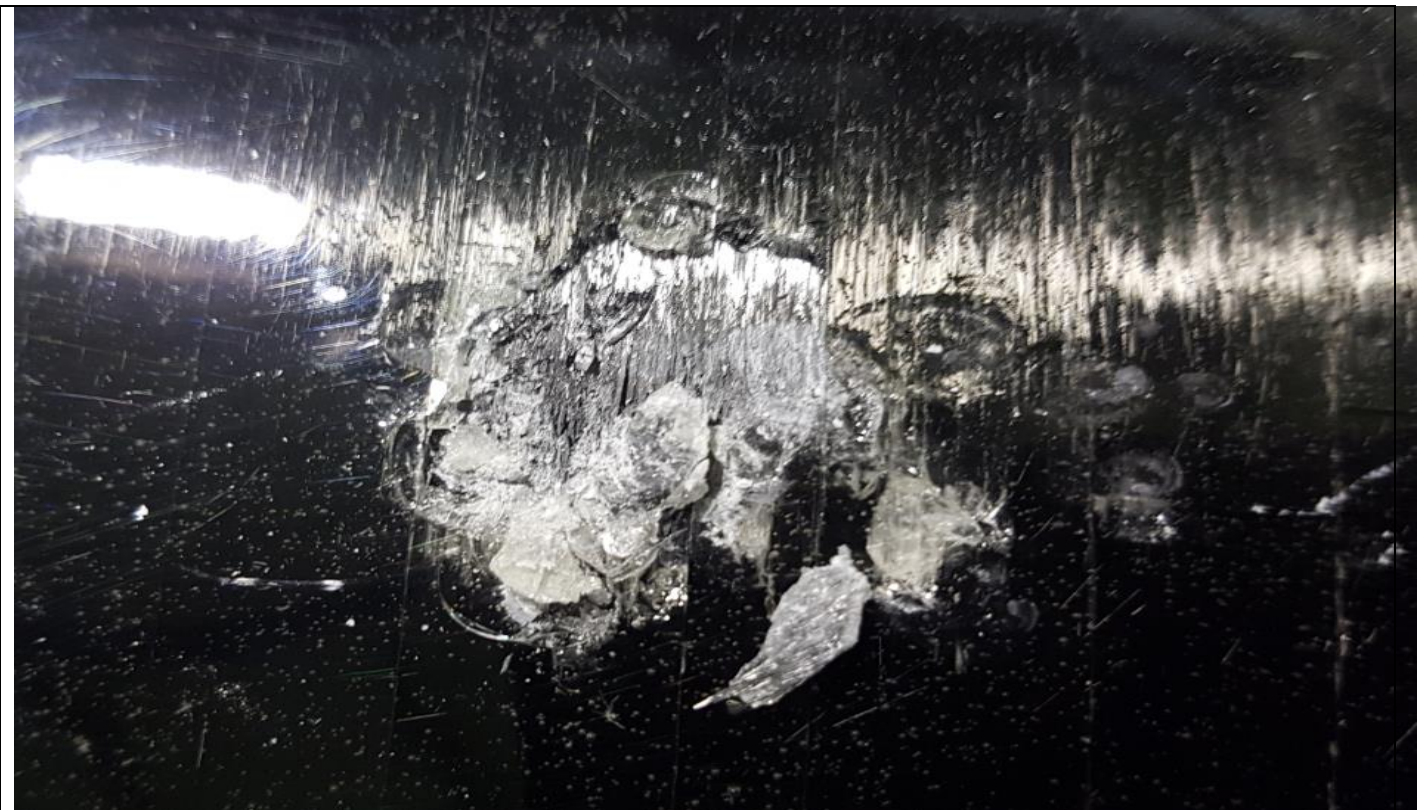
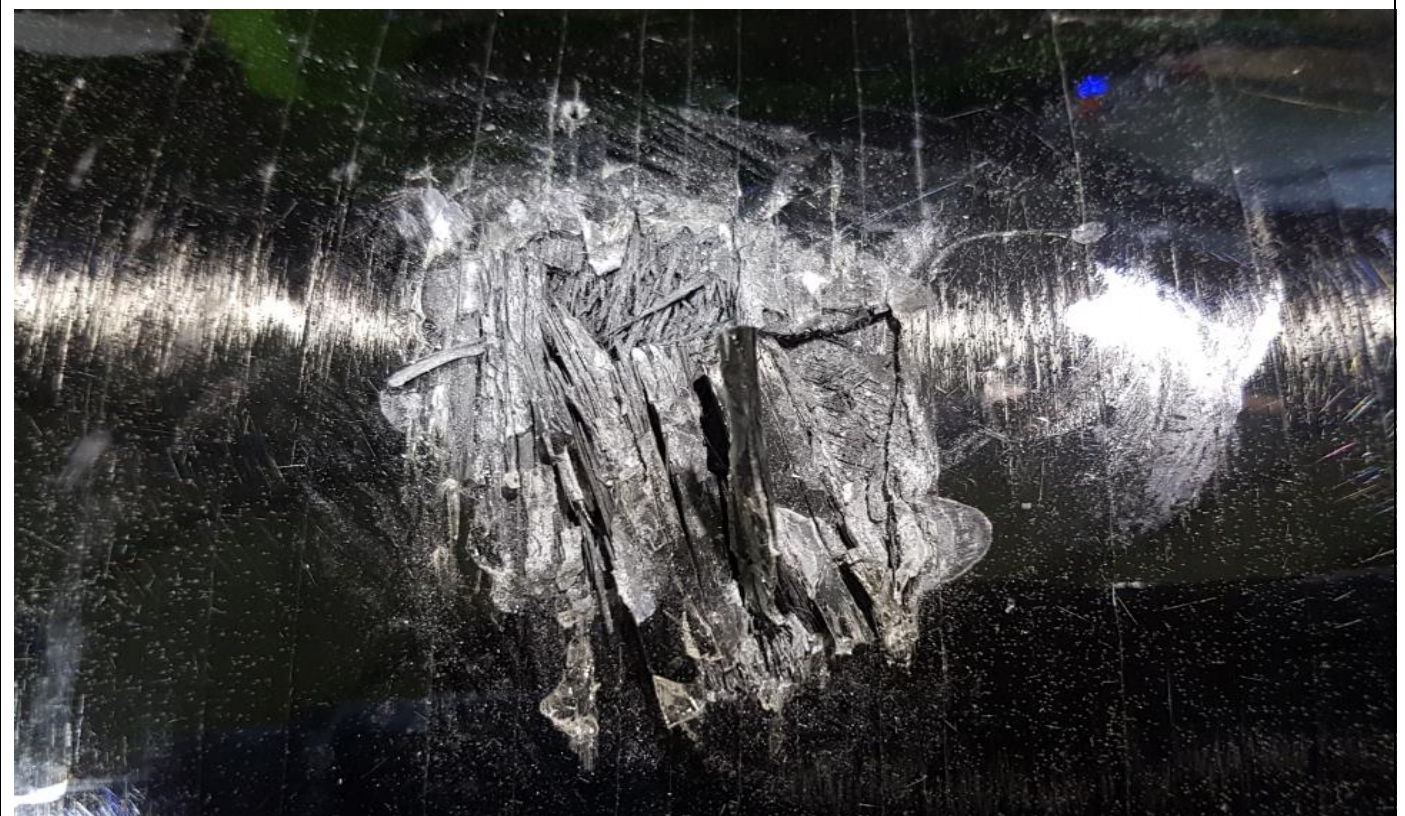
Level 3 impact are severe damages and suspected to have got the liner denting or major structure damage in the cylinders. In this case, the cylinders must be condemned, removed from service and destroyed.

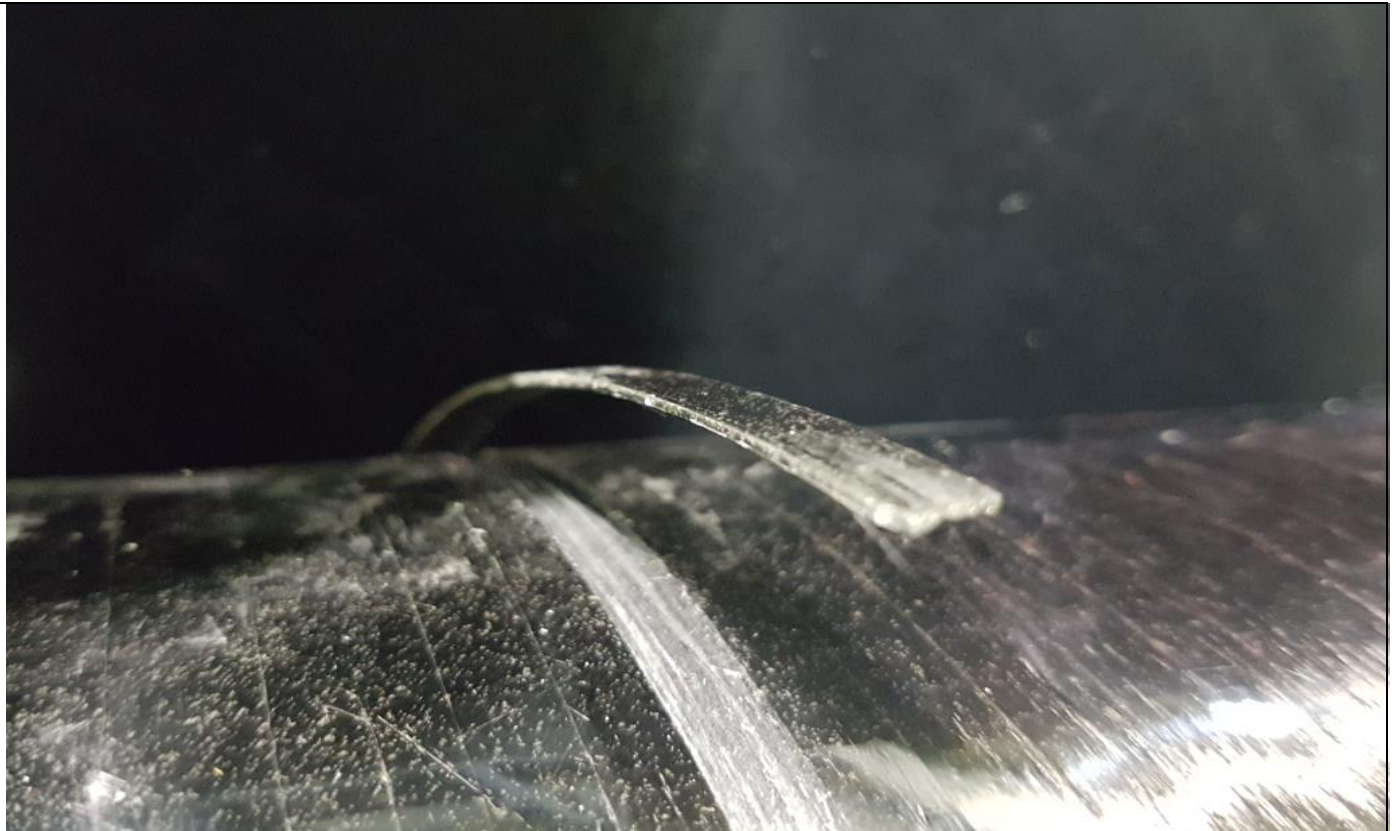
Delamination

This photo shows the carbon fiber delaminating from the cylinder surface.

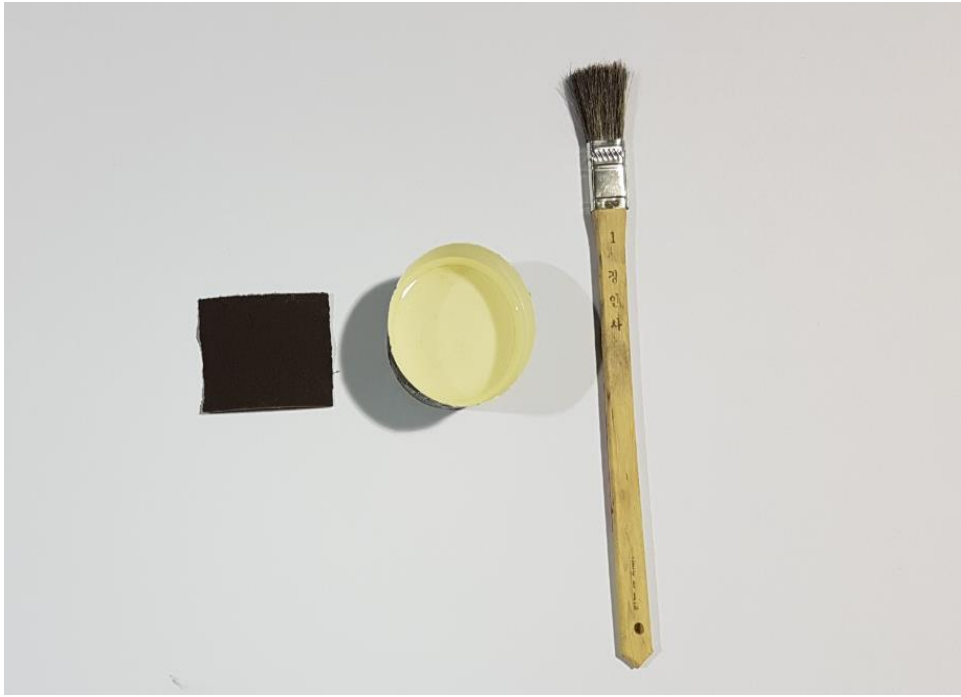
- sandpaper, 2-part epoxy resin for repair, brush, etc .. are needed to repair damages except Level 3 damage

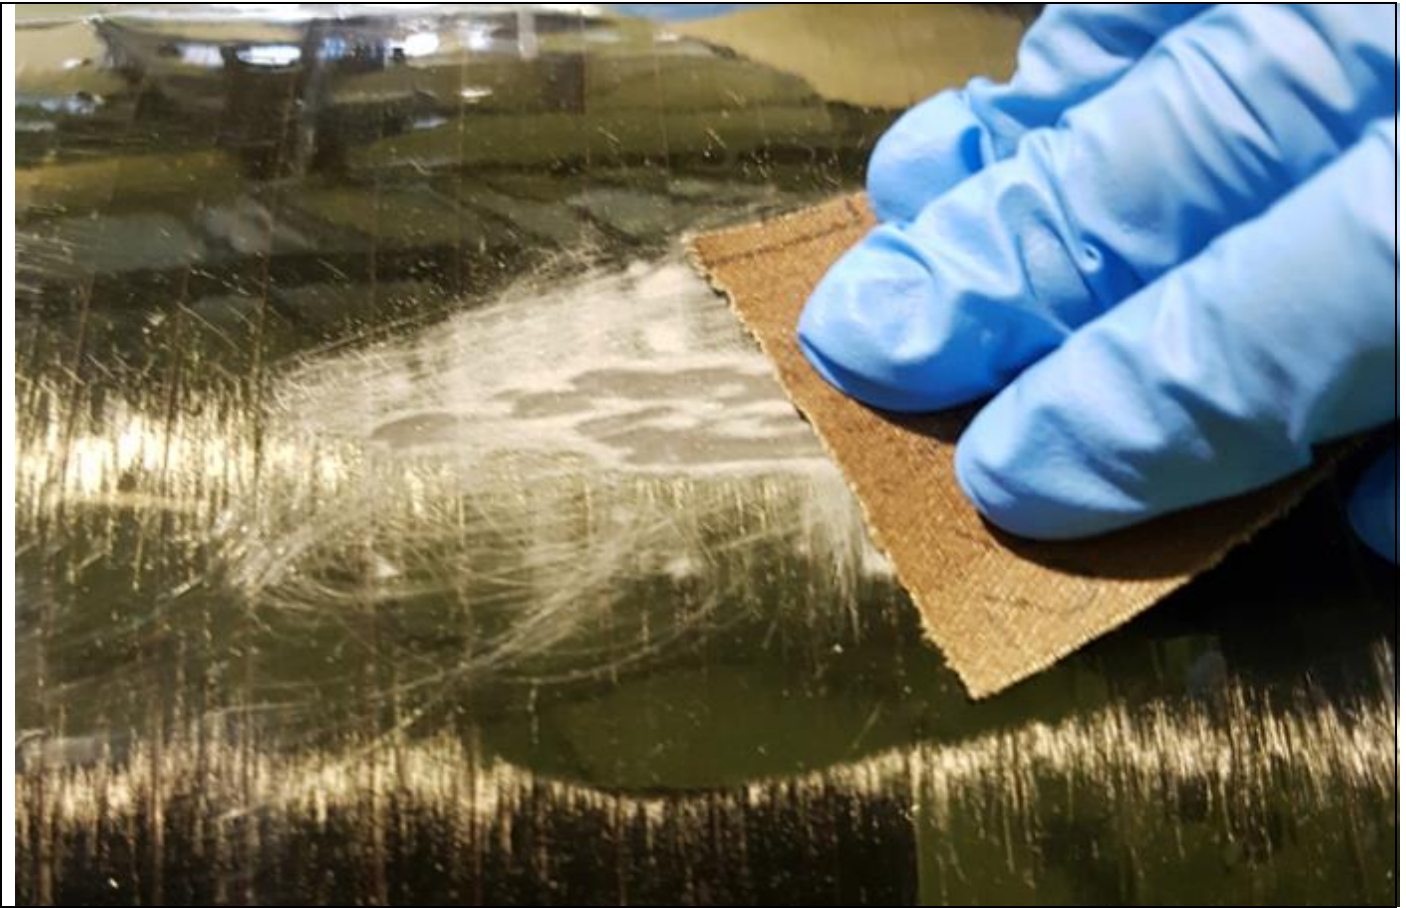
Sand damaged area with a sandpaper

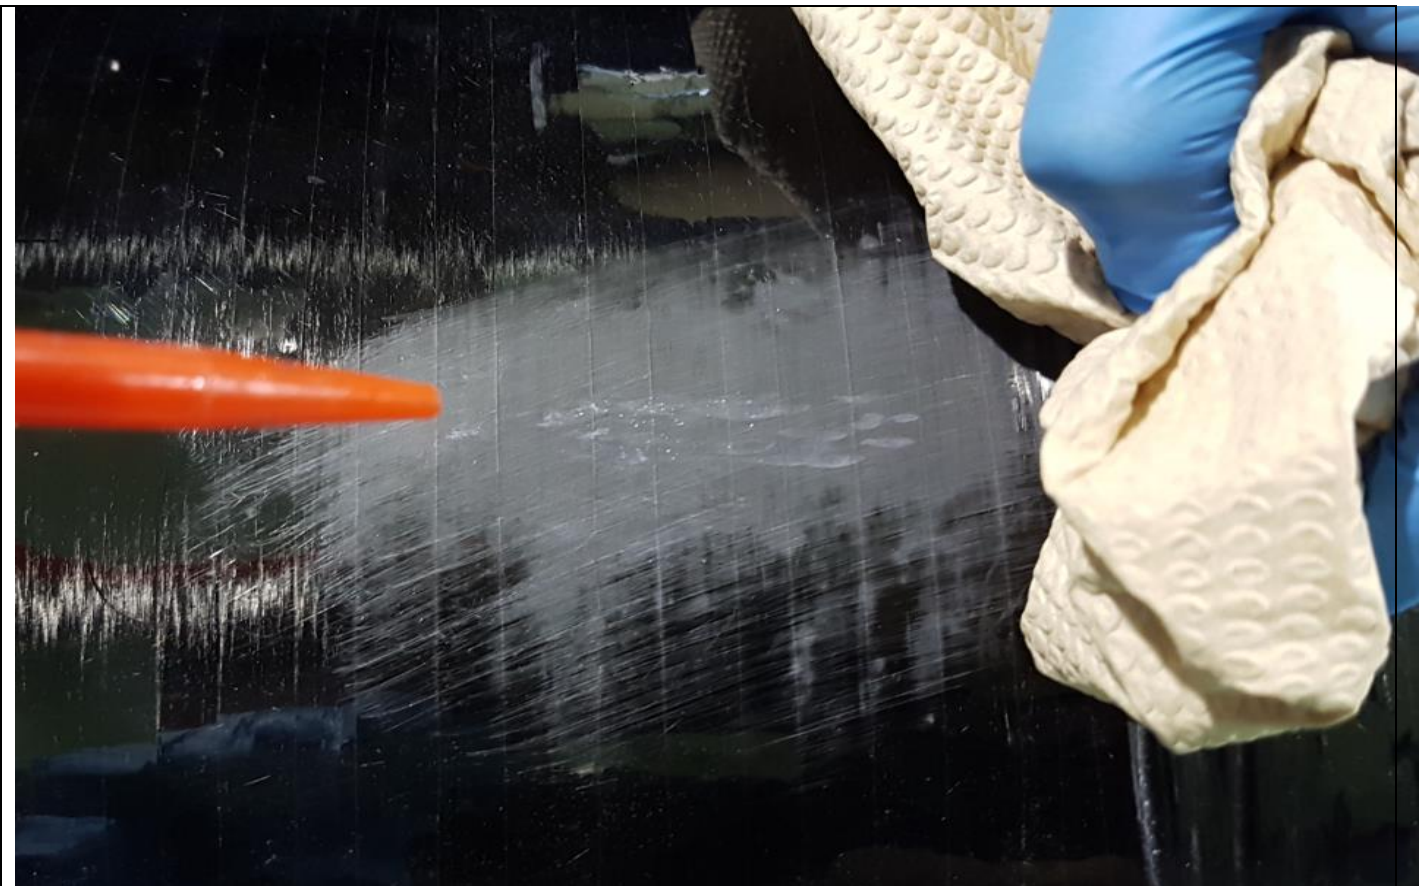
Clean the damaged area after sanding

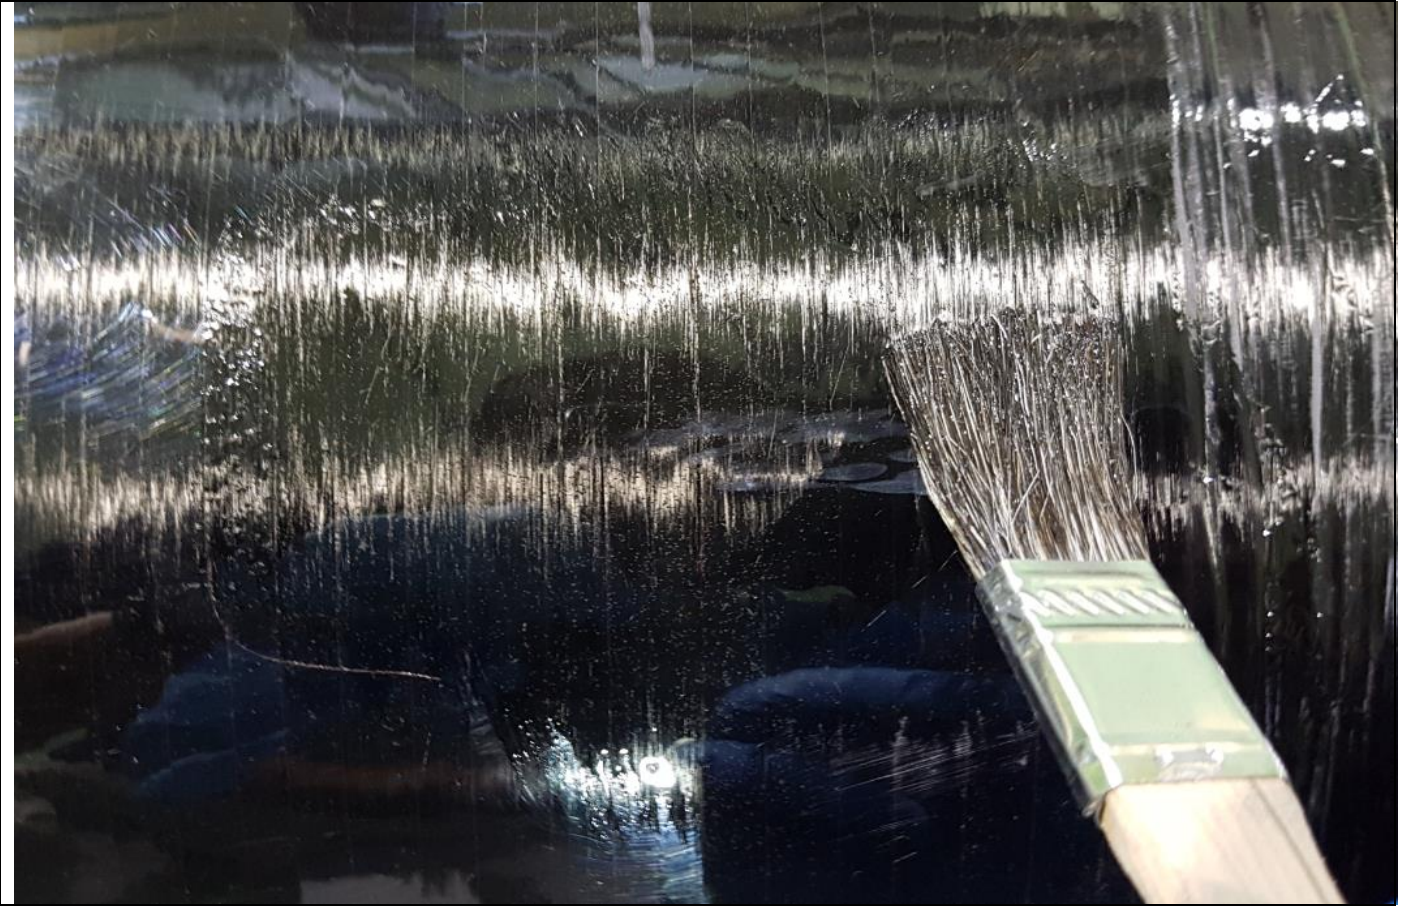
Resin application

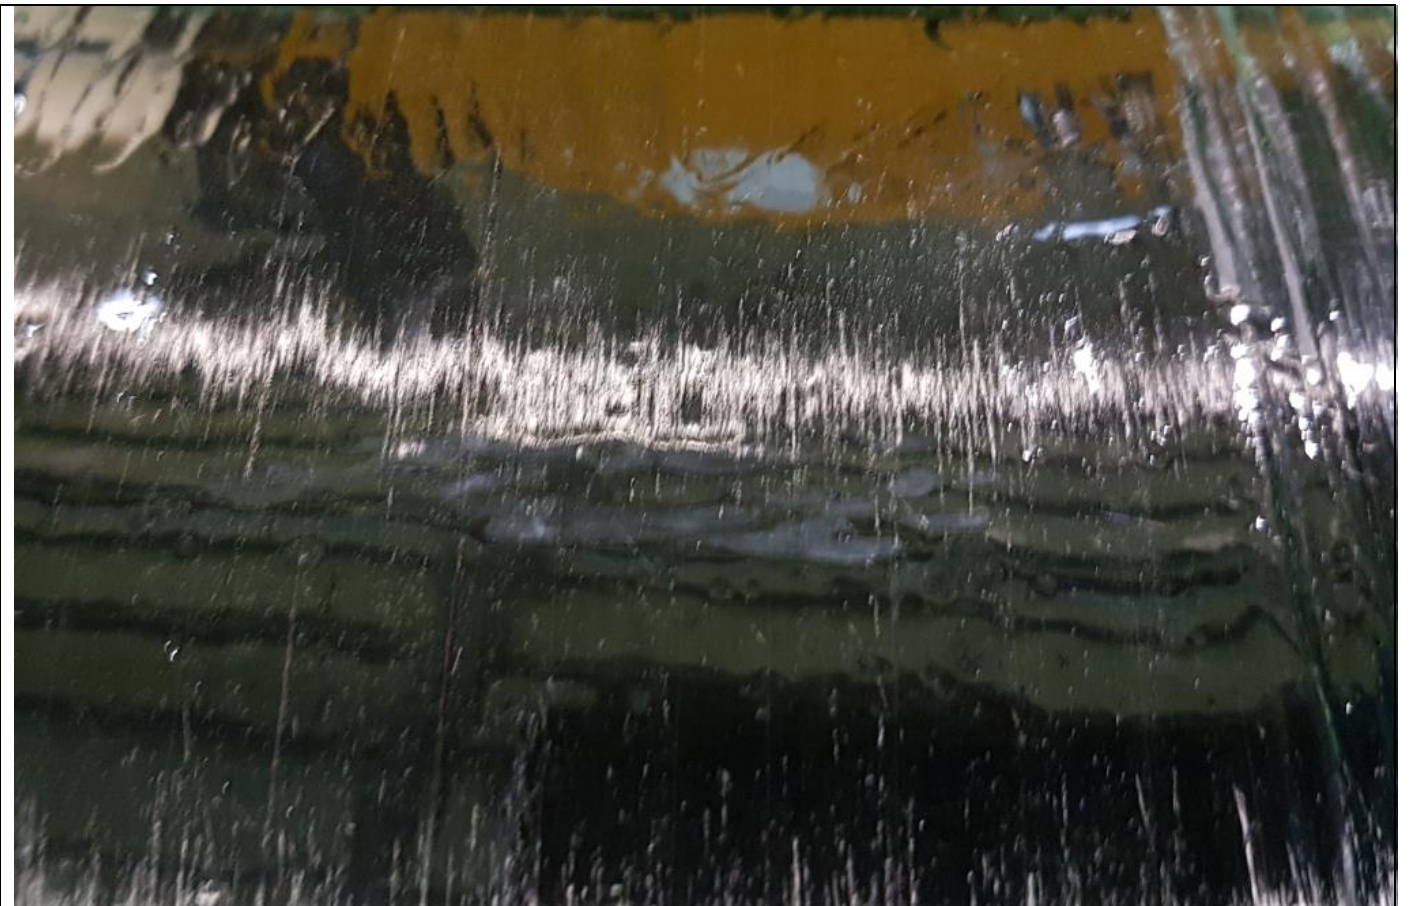
After cure
